Re: Fw: RV7 HS Construction Questions

> Subject: RV7 HS Construction Questions

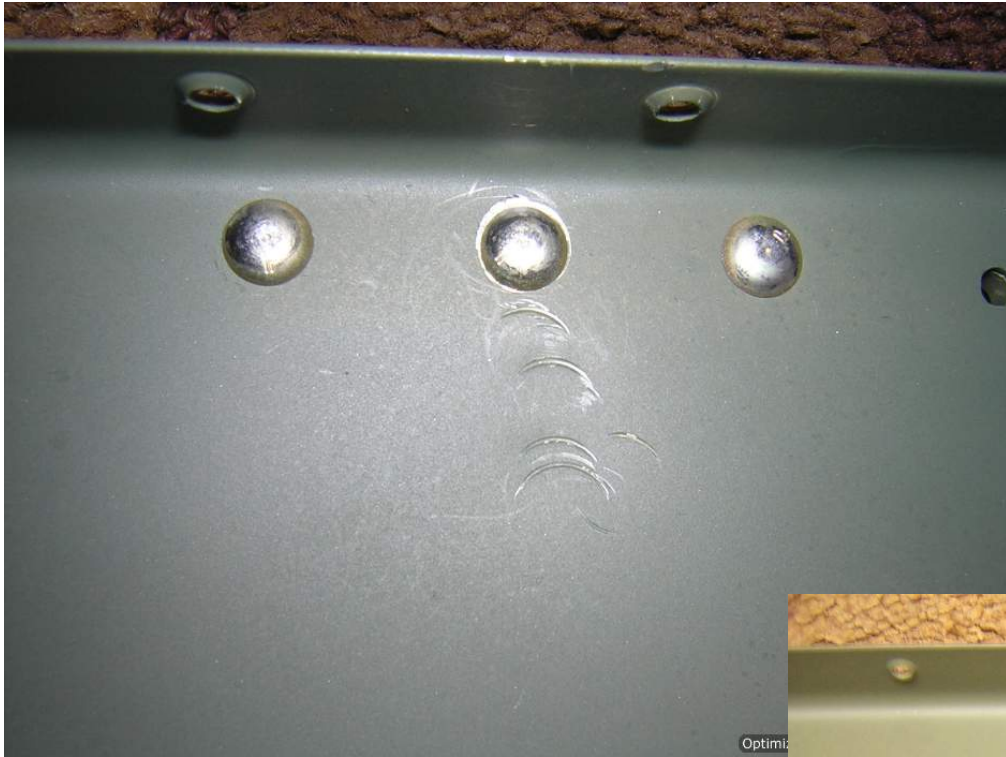
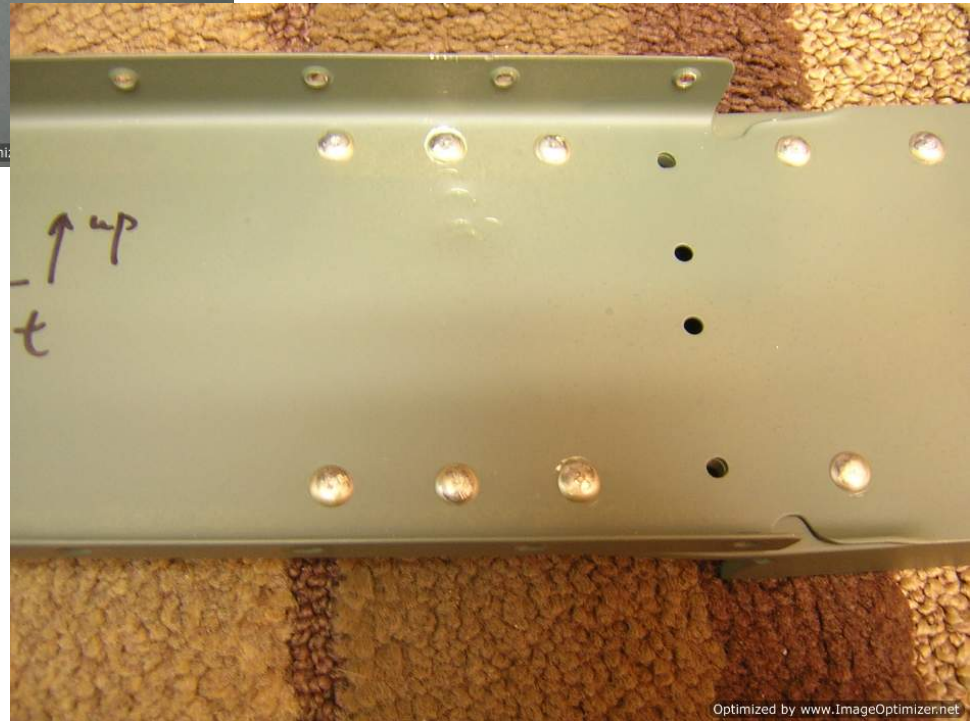
Cause: rivet gun slipped during riveting

Stress is very low, and the buckling shear strength is 15 ksi (see next slide), not a concern. The smoothness over the dent area is checked ok, and no initial cracks observed, fatigue is also not a concern here.

> Started riveting the HS, and made some mistakes. I have attached a
> PPT file for illustration.
> 1) Are the smiley on the HS702 ok structural wise?

I don't think they'll be a problem. You could use some scotchbrite or emery cloth to smooth any rough edges just to minimize the chance of cracks in the future.

Thanks, Gus! The area dented by the rivet gun doesn't feel rough (no feeling of any burr or scratch) when running my finger over it, I guess I will just keep the way it is, and will check it during annual (the first annual will be at least 4 years away :-))

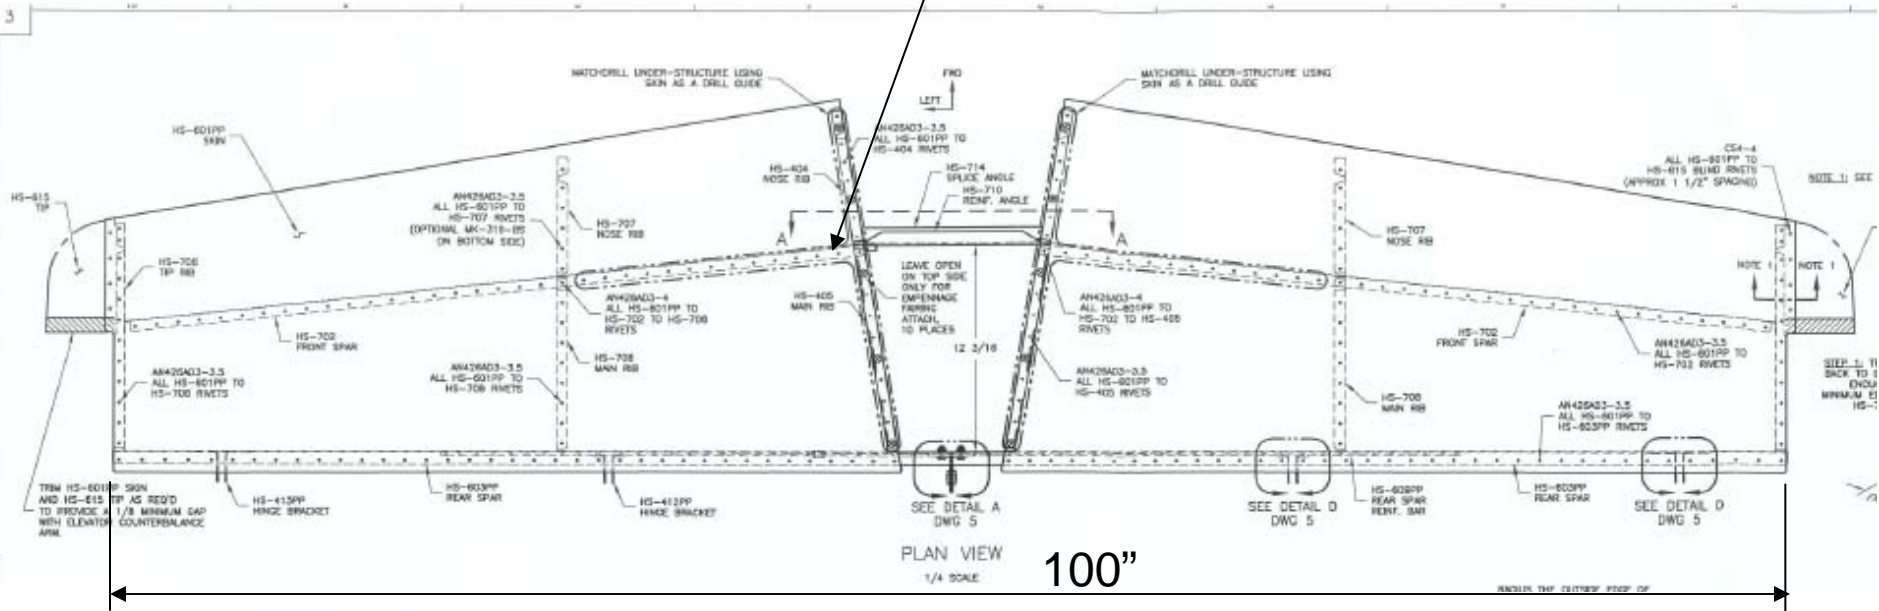
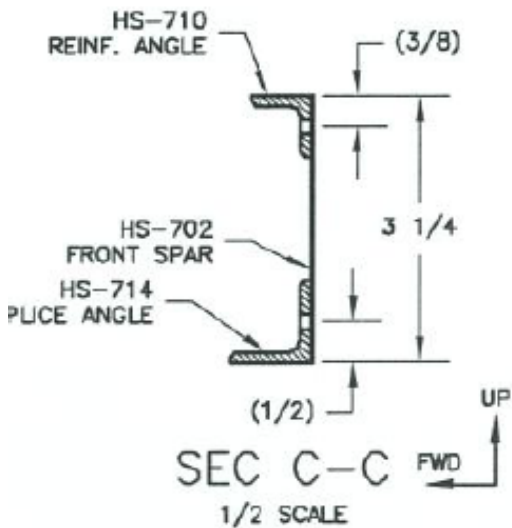
Approximate location of the dent

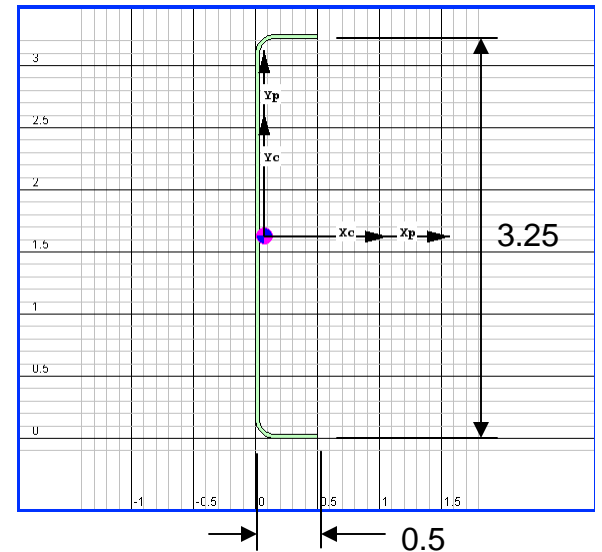
Conservatively only consider the front spar channel at the dent location

Assuming a total of 600 lbs is uniformly applied at horizontal stabilizer. The moment will be taken by both the front and rear spars. The stiffness of rear spar is higher, so the rear spar will take more moment than the front. Assuming the front spar will take half of the total 600 lbs, the dented location will see a shear force of 150 lbs.

$$\text{Shear stress} = 150/0.104 = 1.44 \text{ ksi}$$

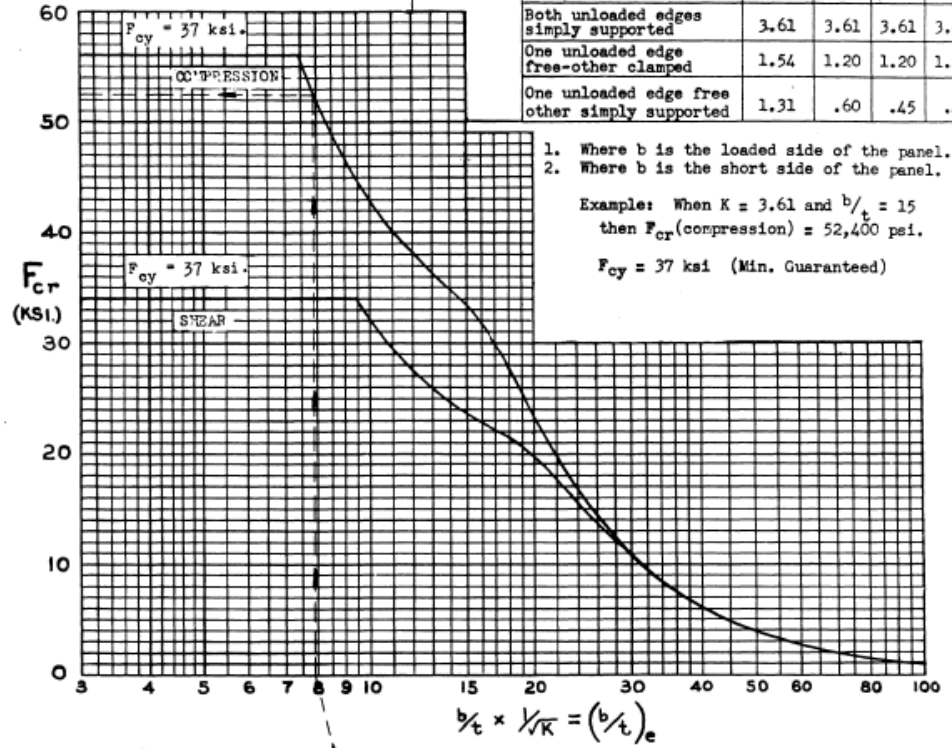
Buckling Strength:
 For $b/t=3.25/0.032 = 101$
 $K = 21.6$
 $F_{cr} = 15 \text{ ksi}$
